U.S.S. TEXAS (BB-35)

OPTION 6 TANK INSPECTION AND REPAIR ASSESSMENT

Vessel Survey Report No. 2461

Purpose of survey: Option 6 Tank Inspection & Repair Assessment

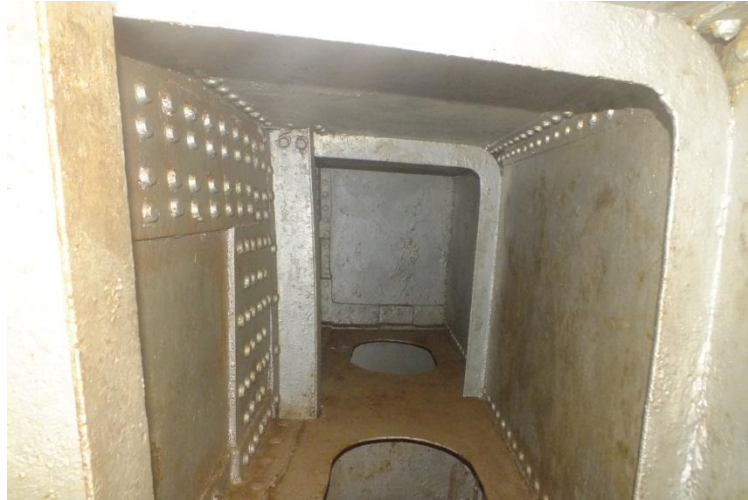
Figure 3. Tank A-63P.

Space is mildly corroded with intact paint system on the upper tank and mild corrosion of shell plating and scantlings as one proceeds to tank bottom. No standing water. This space requires no structural repairs or modifications.

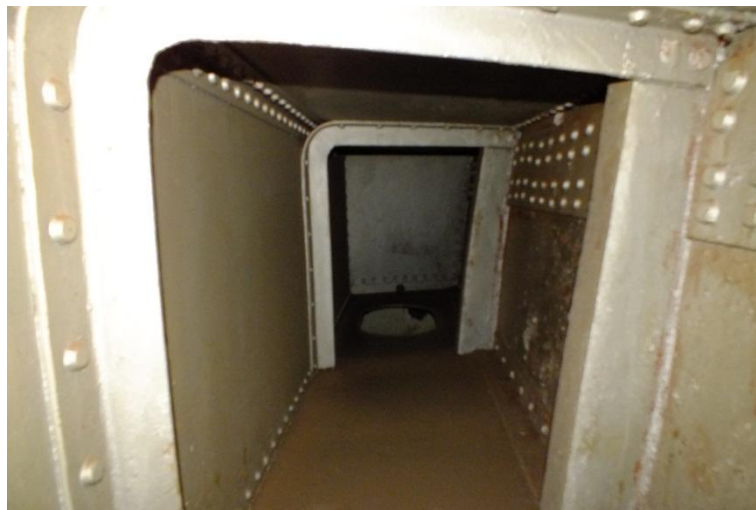
Figure 4. Tank A-64P.

Space is mildly corroded with intact paint system on the upper tank and mild corrosion of shell plating and scantlings as one proceeds to tank bottom. No standing water. This space requires no structural repairs or modifications.

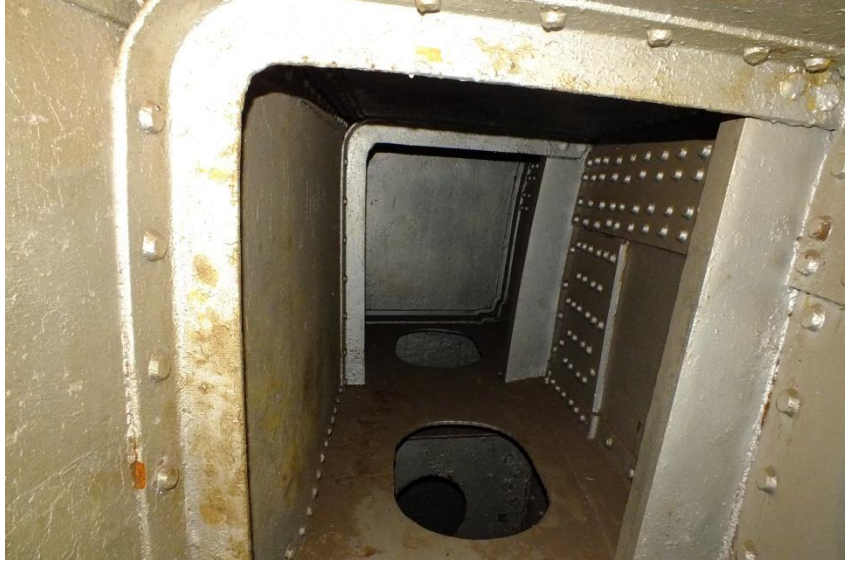
Figure 5. Tank A-65P.

Space is mildly corroded with intact paint system on the upper tank and mild corrosion of shell plating and scantlings as one proceeds to tank bottom. No standing water. This space requires no structural repairs or modifications.

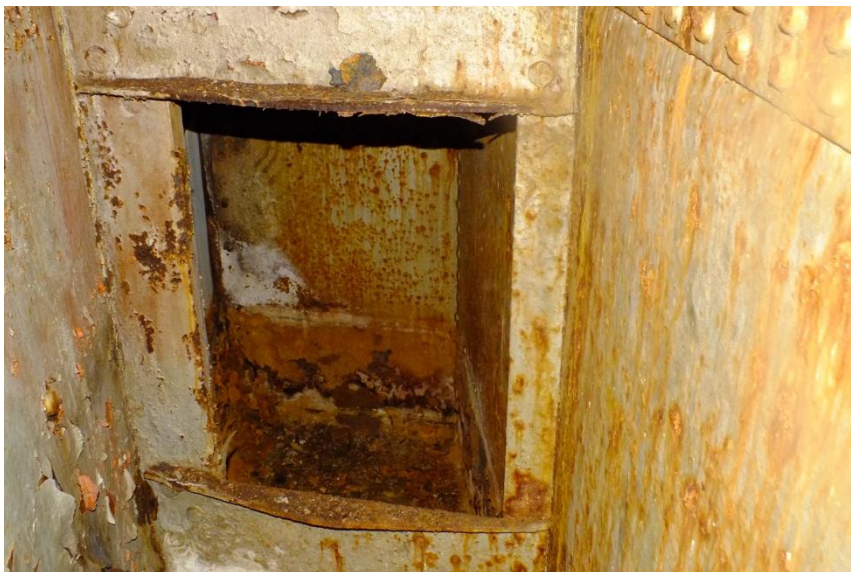
Figure 6. Tank A-66P.

Space is moderately corroded, but not structurally deficient. Side shell and scantling degraded 10 – 15%, floors 20 -30%. No standing water. Peeling paint and rust/scale abound. This space requires no structural repairs or modifications.

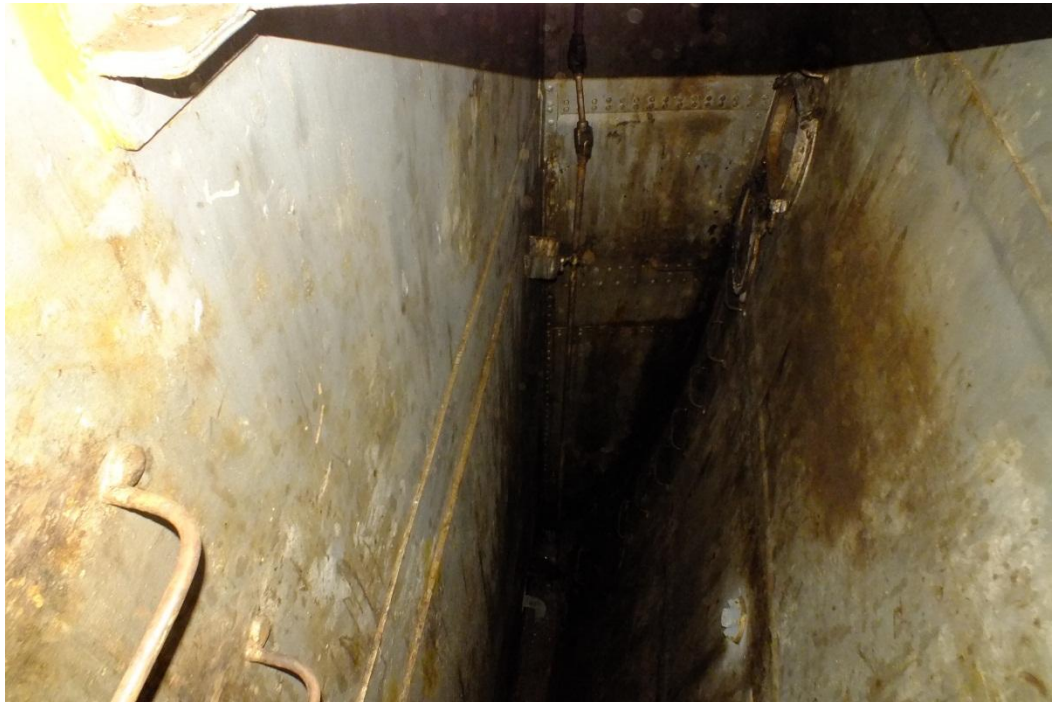
Figure 7. A-67P.

Space is mildly corroded, but not structurally deficient. Side shell and scantling degraded 10 – 15%, floors 20 -30%. No standing water. Peeling paint and rust/scale abound. This space requires no structural repairs or modifications.

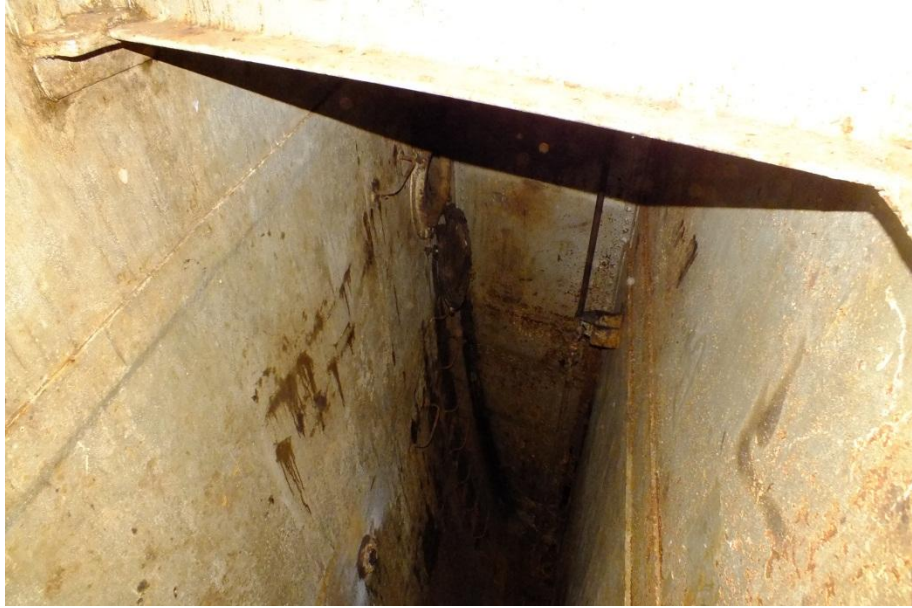
Figure 8. A-68P.

Space is moderately corroded, but not structurally deficient. Side shell and scantling degraded 10 – 15%, floors 20 -30%. 6 – 8” standing water. Peeling paint and rust/scale abound. This space requires no structural repairs or modifications.

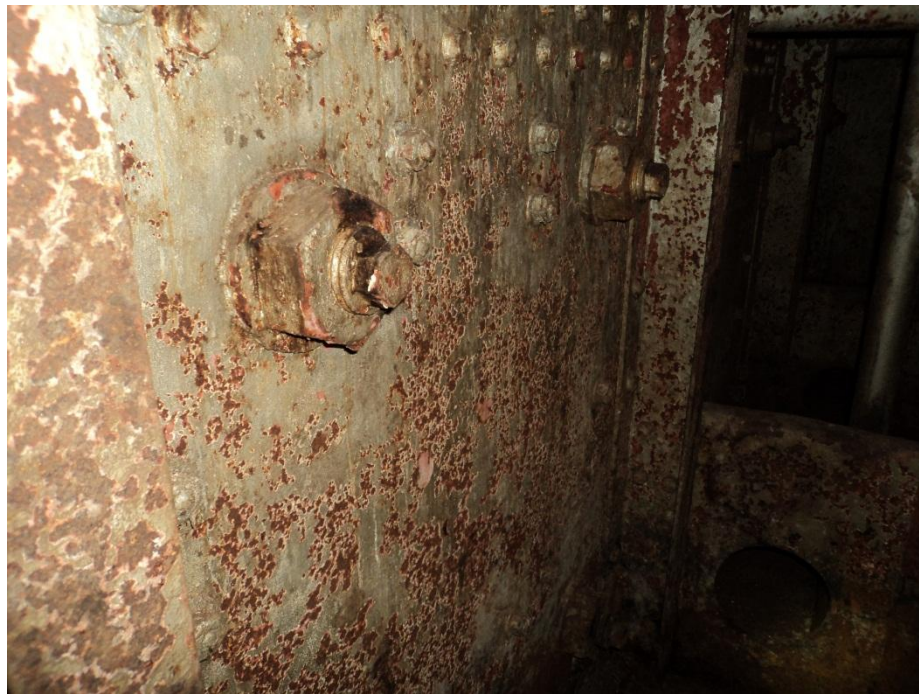
Space is moderately corroded, but not structurally deficient. Side shell and scantling degraded 10 – 15%, floors 30 -40%. No standing water. Peeling paint and rust/scale abound. This space requires no structural repairs or modifications.

Figure 9. Side shell of B-25P showing armor hanging bolts.

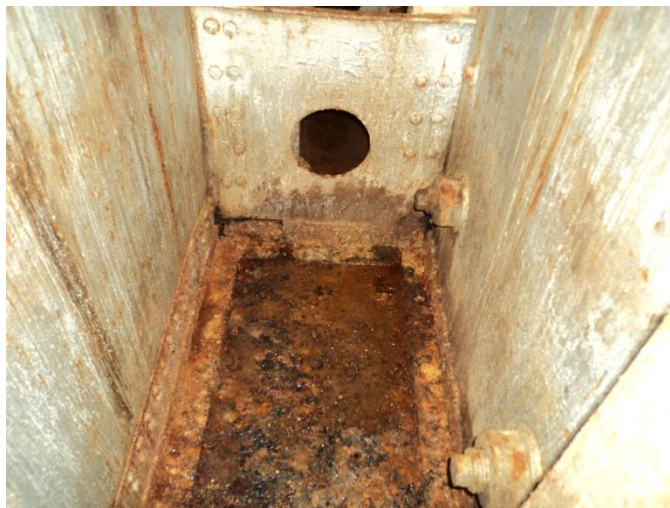
Space is moderately corroded, but not structurally deficient. Side shell and scantling degraded 10 – 20%, floors 30 -40%. 1” standing water. Slight seepage from armor hanging bolts and plate lap joints. Peeling paint and rust/scale abound. This space requires no structural repairs or modifications.

Figure 11. Floor of B-27P showing wetness/seepage of water from armor hanging bolt.

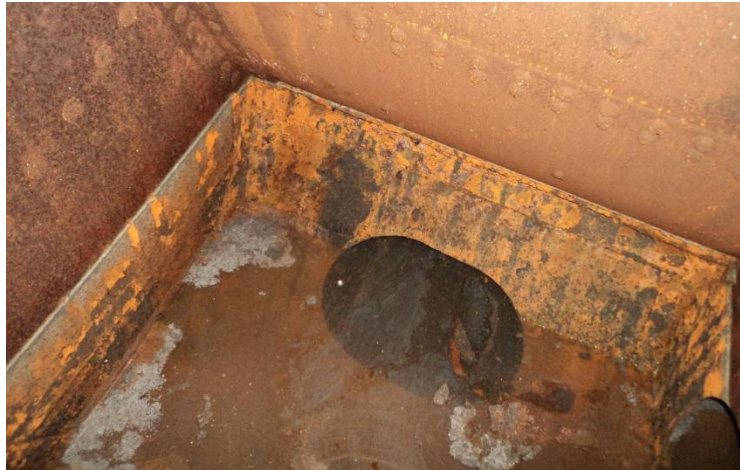
Space is moderately corroded, but not structurally deficient. Upper tank side shell and scantling degraded 20 – 30%, floors 30%. Intermediate side shell and scantlings degraded 20 – 30% with oil seepage from behind riveted plate lap seams. **Lower tank side shell and scantlings degraded 40 % with 8' of standing water at bottom of tank.** Peeling paint and much rust/scale abound.

Figure 12. Standing water in B-76F at turn of bilges.

Dewater tank, inspect and renew with ¾" A-36 mild steel doubler plating as needed. Estimate 400 sq. ft.

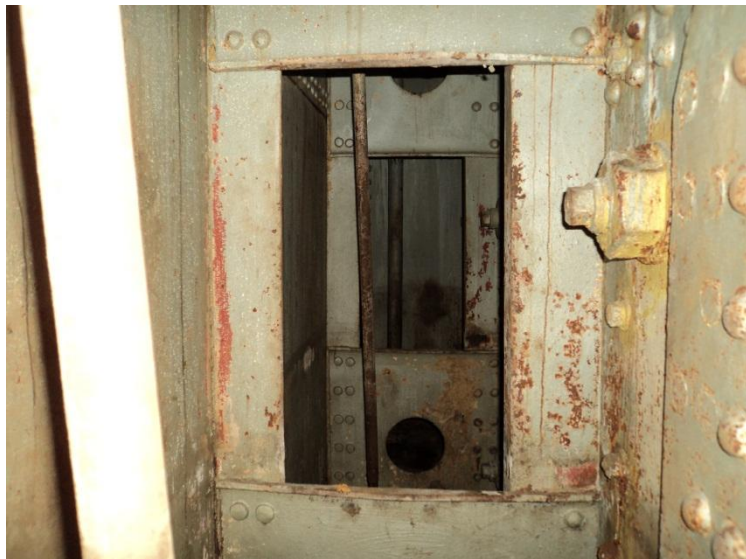
Space is mildly corroded with intact paint system on the upper tank and mild corrosion of shell plating and scantlings as one proceeds to tank bottom. No standing water. This space requires no structural repairs or modifications.

Figure 13. B-28P in good material condition.

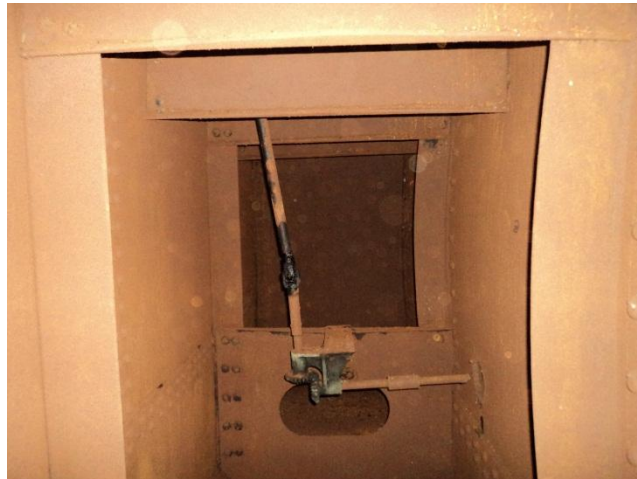
Space is moderately corroded, but not structurally deficient. Upper tank side shell and scantling degraded 20 – 30%, floors 30%. Upper shell plating dished in 3" throughout space; appears to be a very old condition. **Intermediate side shell and scantlings degraded 20 – 30% with a 2" pipe into blister tankage through side shell plating. Bottom scantlings, shell plating degraded 25 – 30% with a 6" pipe through side shell into blister tankage.** Peeling paint and much rust/scale abound. No standing water.

Figure 14. Dished in shell plating on right side of photo in B-76F on upper flat.

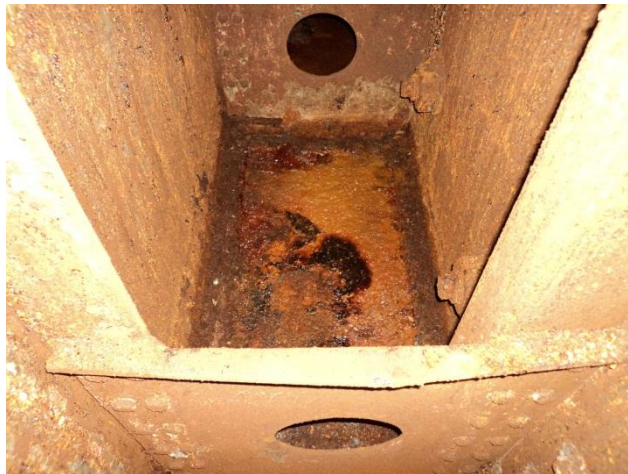
Figure 15. Bottom plating in B-29P.

Space is moderately corroded, but not structurally deficient. Side shell and scantling degraded 10 – 20%, floors 30 -40%. ½" standing water. Slight seepage from armor hanging bolts and plate lap joints. Peeling paint and rust/scale abound. This space requires no structural repairs or modifications.

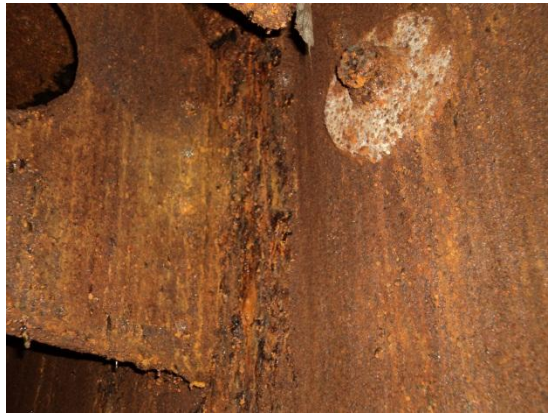
Space is moderately corroded, but not structurally deficient. Upper tank side shell and scantling degraded 20 – 30%, floors 30%. Upper shell plating dished in 3" throughout space; appears to be a very old condition. **Intermediate side shell and scantlings degraded 50%+ with oozing water behind heavy rust through side shell plating. Bottom scantlings, shell plating buckled with wetness behind heavy rust in various areas degraded 30 – 50% through side shell into blister tankage..** Peeling paint and much rust/scale abound. 2' standing water.

Figure 16. Side shell plating in intermediate flat of B-80F showing wasted armor hanging bolt & wetness through side shell plating.

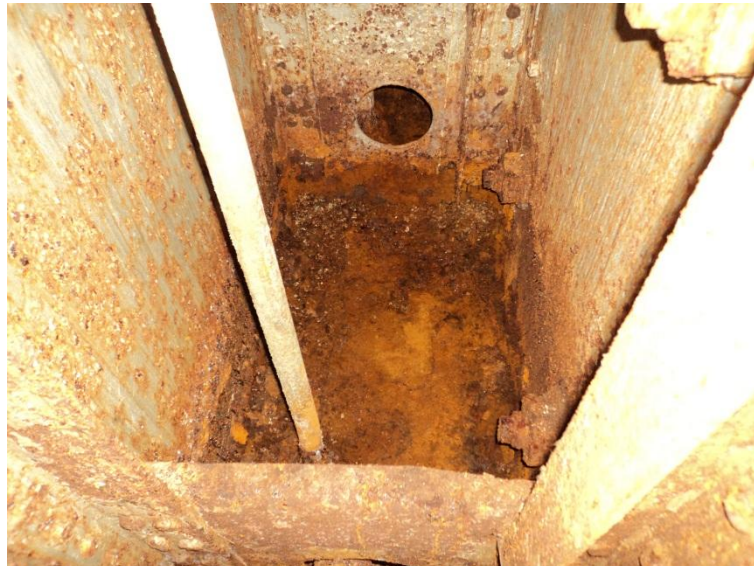
Figure 17. Lower portion of tank showing flooring in B-30P.

Space is moderately corroded, but not structurally deficient. Much mold throughout space indicating previous wetness and poor ventilation. Side shell and scantling degraded 30 – 40%, floors 30 -40%. No standing water. Peeling paint and rust/scale abound. This space requires no structural repairs or modifications.

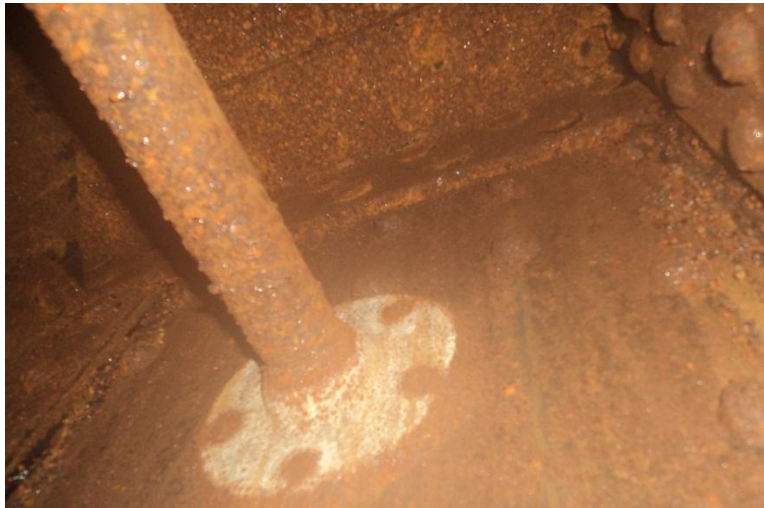
Space is moderately corroded, but not structurally deficient. Upper tank side shell and scantling degraded 20 – 30%, floors 30% with minor seepage of oil from riveted plate lap seams throughout. **Intermediate side shell and scantlings degraded 30 – 40% with a single 4" pipe and a single 2" pipe into blister tankage through side shell plating.** Bottom scantlings, shell plating degraded 25 – 30% with minor seepage of oil from riveted plate lap seams throughout. Peeling paint and much rust/scale abound. 1 -2" of standing water/oil in bilges.

Figure 18. 4" pipe through side shell plating on intermediate flat of B-82F.

Verify that blister tankage outboard is dry, remove piping and weld two (2) 12" x 12" $\frac{3}{4}$ " A-36 mild steel doubler plate over holes in side shell.

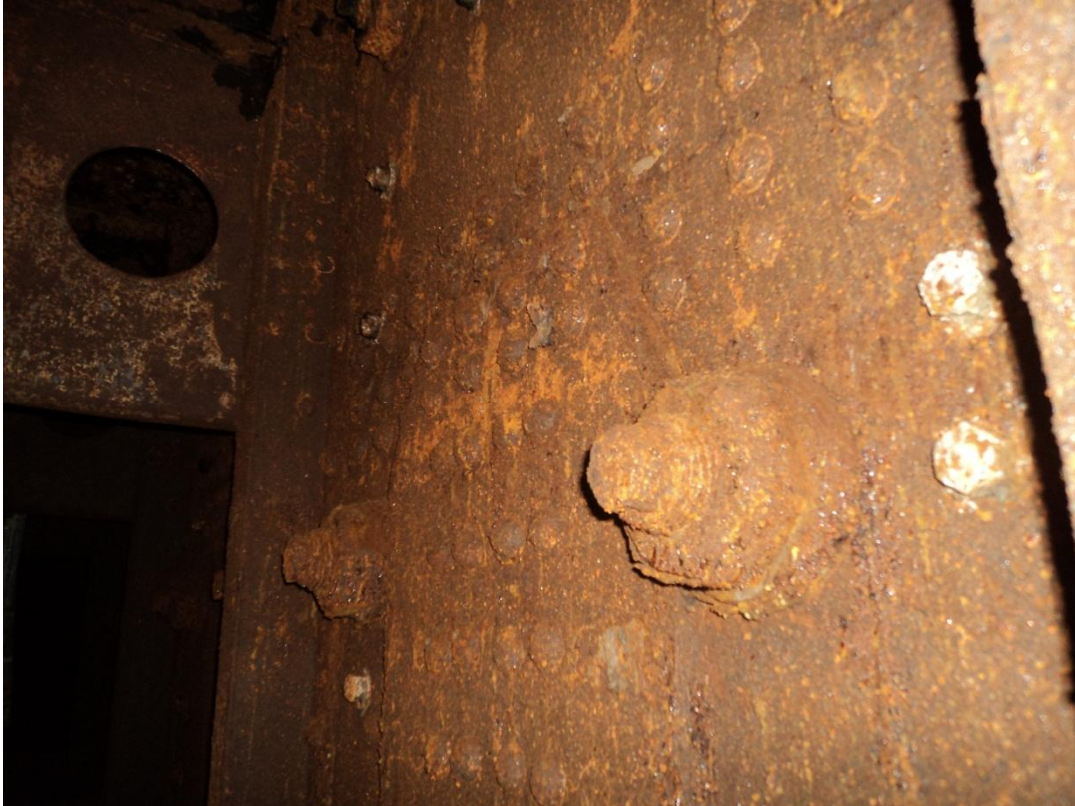
Figure 20. Side shell plating showing armor hanging bolts in B-31P.

Space is moderately corroded, but not structurally deficient. Side shell and scantling degraded 20 – 30%, floors 30 -40%. No standing water. Slight seepage of oil from riveted lap seams. Peeling paint and rust/scale abound. This space requires no structural repairs or modifications.

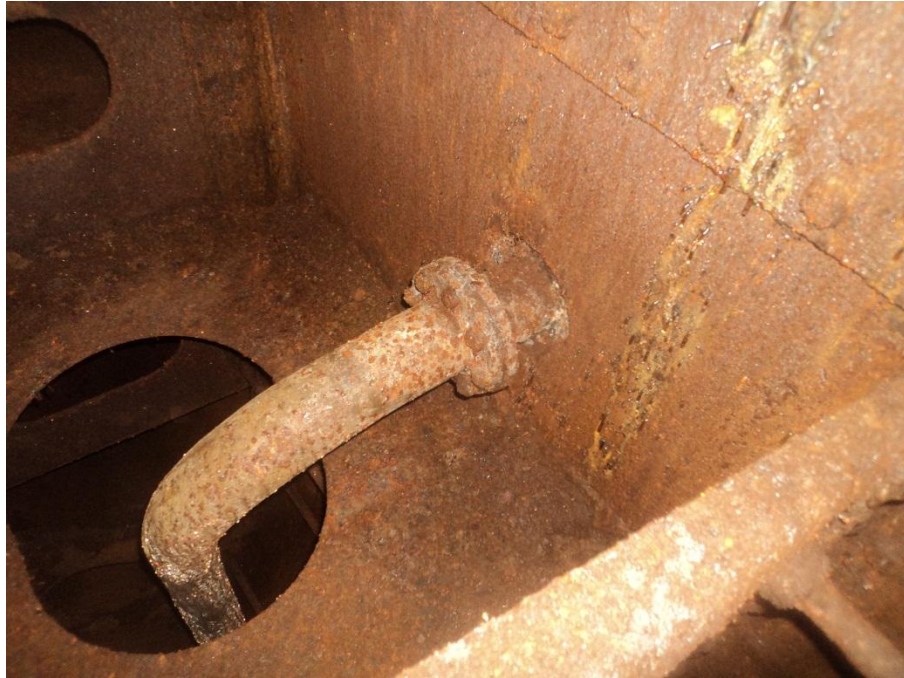
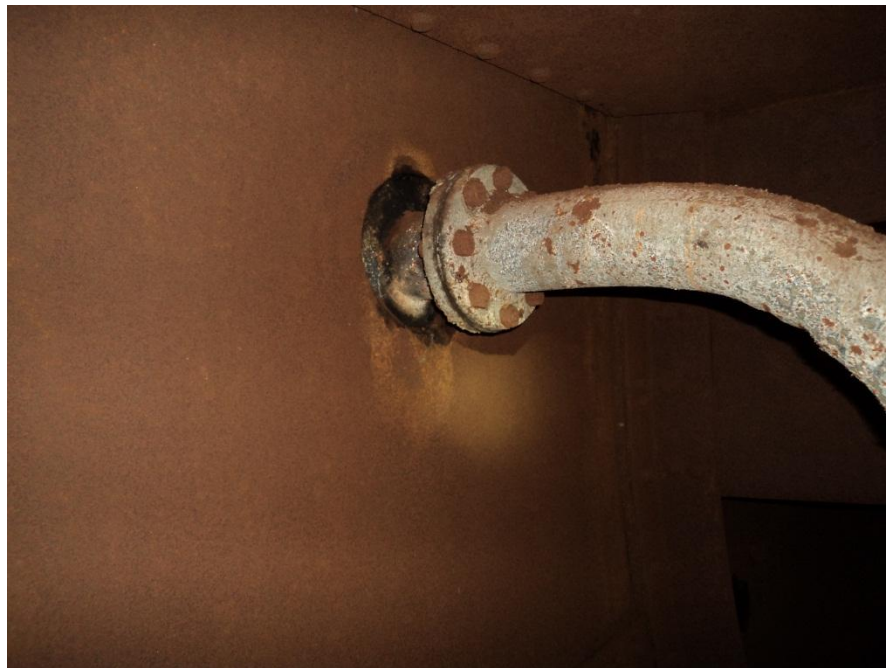
Space is moderately corroded and structurally deficient. **Upper tank side shell and scantling degraded 50 – 70%**, floors 30% with minor seepage of oil from riveted plate lap seams throughout. A 2” pipe is through to the blister tank from the upper flat. An 8’ x 12’ and a 14’ x 30’ section of shell plating is weeping water from the blister tankage.

Intermediate side shell and scantlings degraded 50 – 70% with weeping rivets throughout; a single 4” pipe is fitted into blister tankage through side shell plating. Bottom scantlings, shell plating degraded 25 – 40% with minor seepage of oil from riveted plate lap seams throughout; a 5” pipe extends through shell plating into blister tankage. Peeling paint and much rust/scale abound. 6” of standing water/oil in bilges. Framing buckled, but not in danger of tripping throughout bottom of tank space.

Figure 21. Piping going through side shell in B-84F.

Figure 22. Piping going through side shell in B-84F

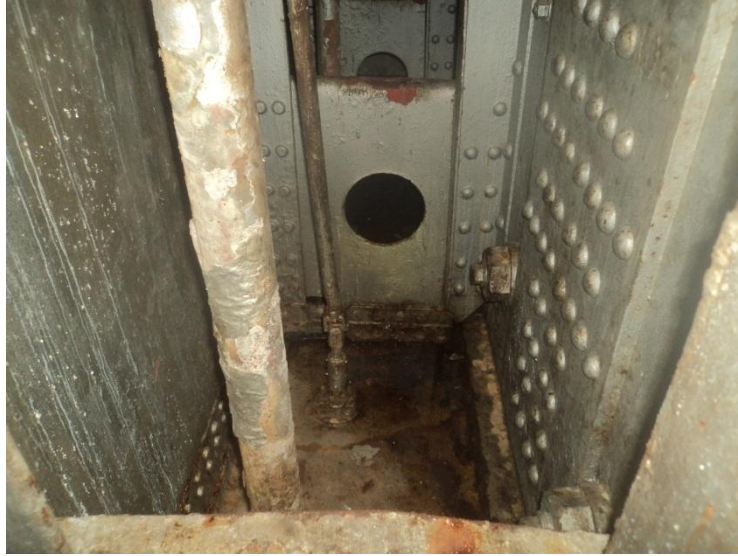
Figure 23. Tank C-44P.

Space is mildly corroded with intact coatings, but not structurally deficient. Side shell and scantling degraded 10%, floors 20%. 1" standing water/oil. Slight seepage of oil from riveted lap seams. This space requires no structural repairs or modifications.

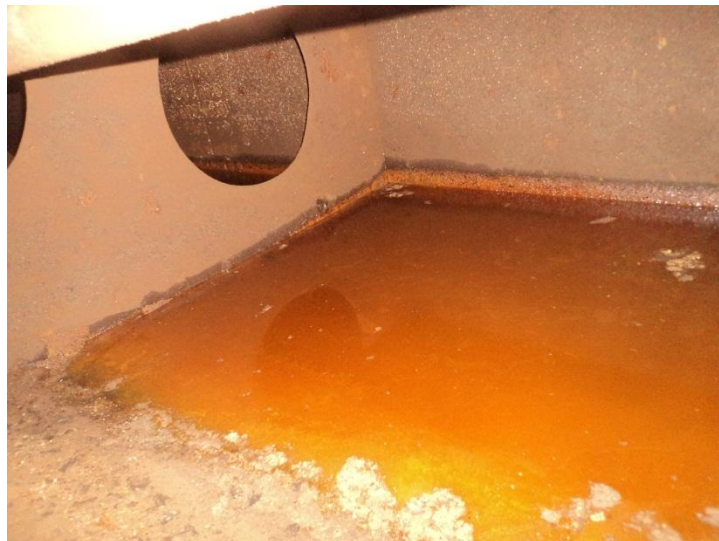
Space is moderately corroded, but not structurally deficient. Upper tank side shell and scantling degraded 20%, floors 30%. Intermediate side shell and scantlings degraded 30 – 40% with oil seepage from behind riveted plate lap seams. Bottom scantlings and shell plating show 30 – 40% degradation with 3" of standing water/oil at bottom of tank. Peeling paint and much rust/scale abound.

Figure 24. Tank C-80F showing standing oil/water on bottom.

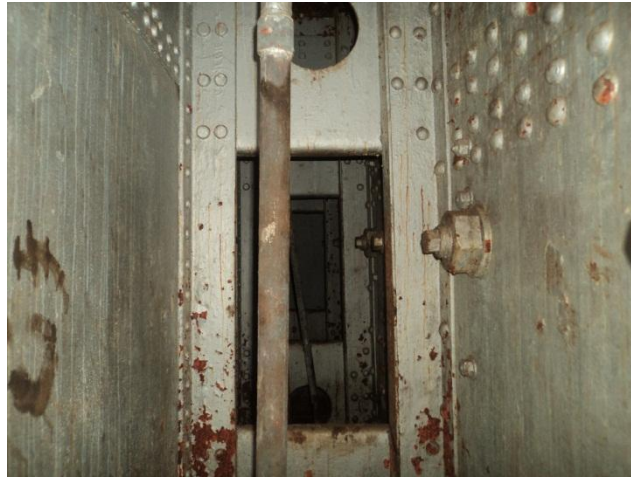
Figure 25. View of interior of C-45P.

Space is mildly corroded with intact coatings, not structurally deficient. Side shell and scantling degraded 10%, floors 20%. No standing water/oil. Slight seepage of oil from riveted lap seams on inboard and outboard shell. This space requires no structural repairs or modifications.

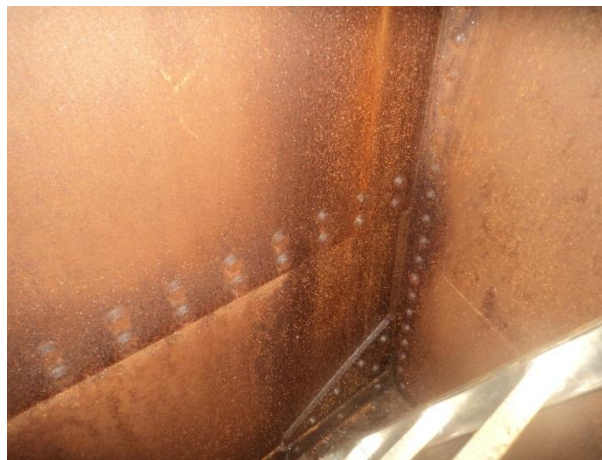
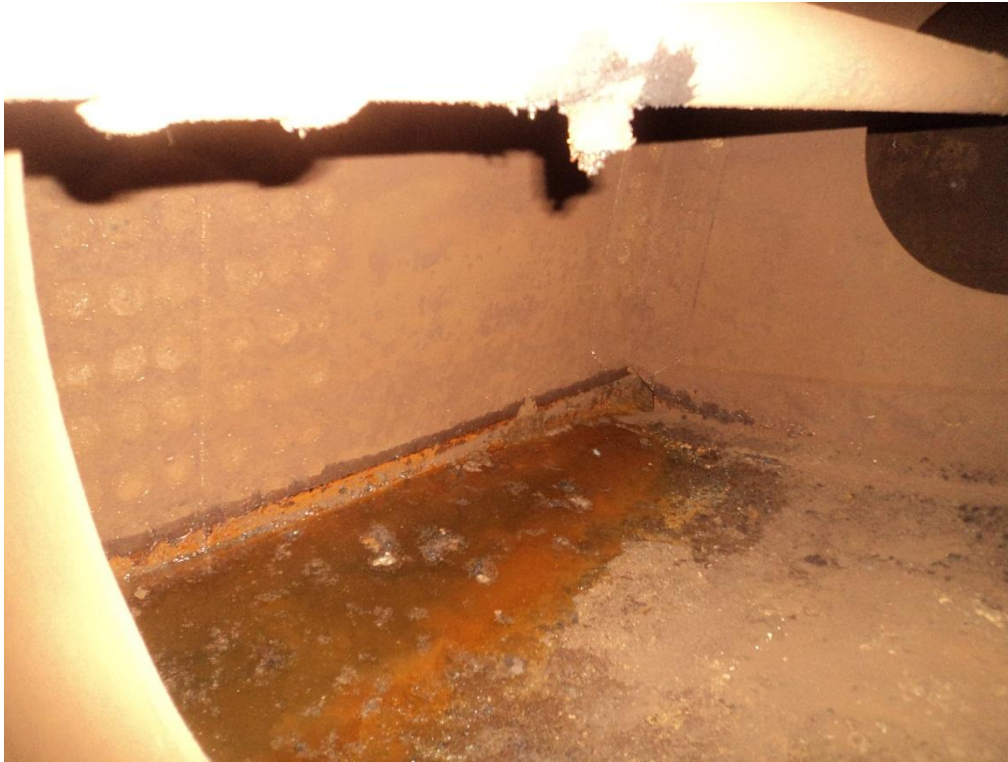
Space is moderately corroded, but not structurally deficient. Upper tank side shell and scantling degraded 20%, floors 30%. Intermediate side shell and scantlings degraded 20 – 30% with water seepage from behind riveted plate in an 8' x 20' section to be repaired by ring welding rivets. Bottom scantlings and shell plating show 30 – 40% degradation weeping rivets in a 7' x 20' section with 4" of standing water/oil at bottom of tank. Peeling paint and much rust/scale abound.

Figure 26. Intermediate flat showing weeping rivets in C-82F.

Figure 27. Bottom standing water/oil in C-82F.

Ensure adjacent blister tankage is dry. Properly prepare shell plating and install approximately 300 square feet of $\frac{3}{4}$ " A-36 mild steel doubler plating.

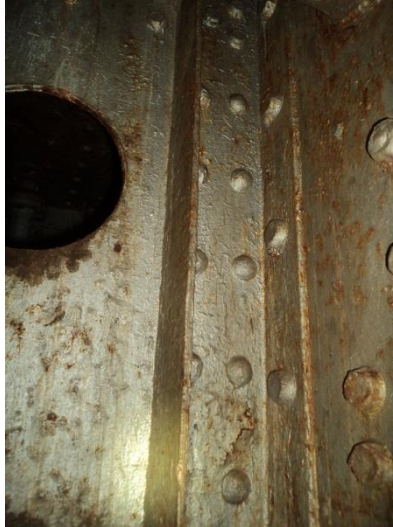
Figure 28. Interior of C-48P.

Space is mildly corroded with intact coatings, not structurally deficient. Side shell and scantling degraded 10%, floors 20%. No standing water/oil. Slight seepage of oil from riveted lap seams on inboard and outboard shell. This space requires no structural repairs or modifications.

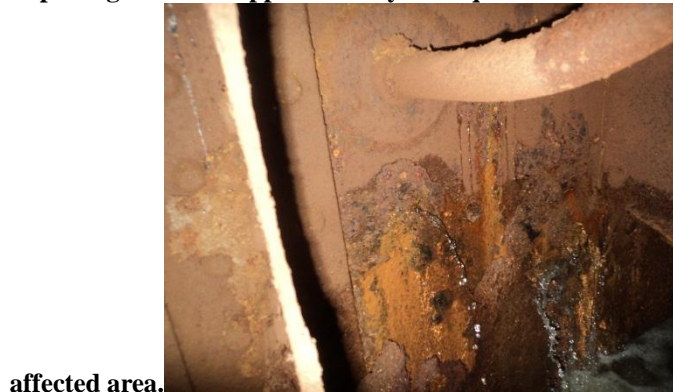
This tank is flooded almost to the top. A 4" pipe is through the side shell into the blister on the upper flat. Water is leaking through the side shell plating in many areas; this tank needs to be de-watered and patched. The exterior blister tank will also need to be repaired/patched before any repairs can be accomplished. Estimate 8' x 30' section of shell plating to be doubled/repaired.

Figure 29. Interior of upper flat to C-88F showing leaking shell plating.

Properly prepare shell plating and weld approximately 240 square feet of $\frac{3}{4}$ " A-36 mild steel plate to

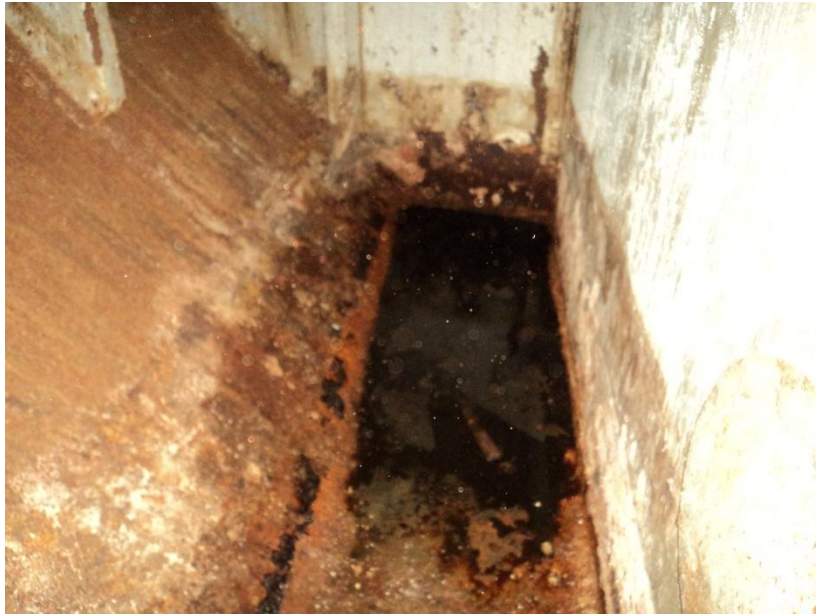
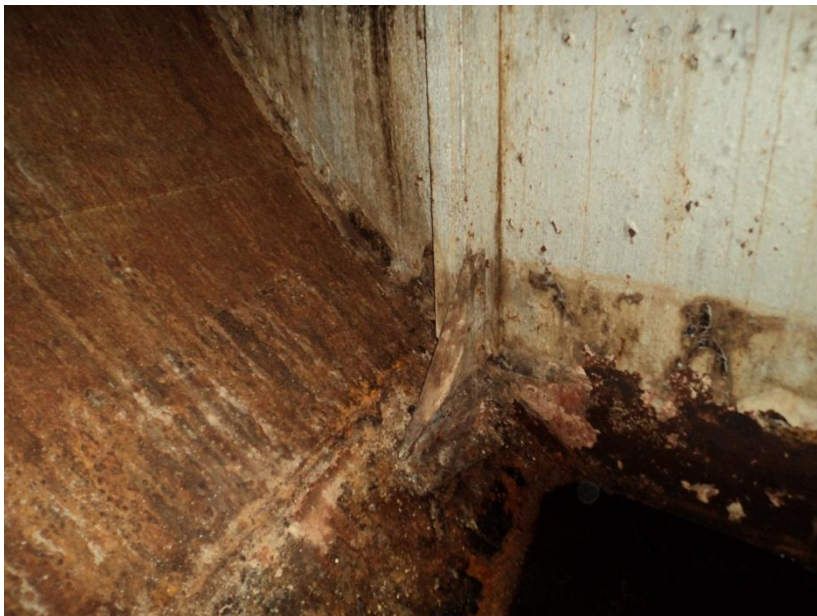
Space is mildly corroded at top with intact coatings; lower compartment has wasted framing. Side shell degraded 20%, floors 30 – 40%, flanges totally wasted. Replace bases of two(4) $\frac{3}{8}$ " vertical flanges on

bottom frames. 3 – 4” standing water/oil. Slight seepage of oil from riveted lap seams on inboard and outboard shell.

Figure 30. View of aft end of D-39P.

Figure 31. Detail of wasted flange in D-39P

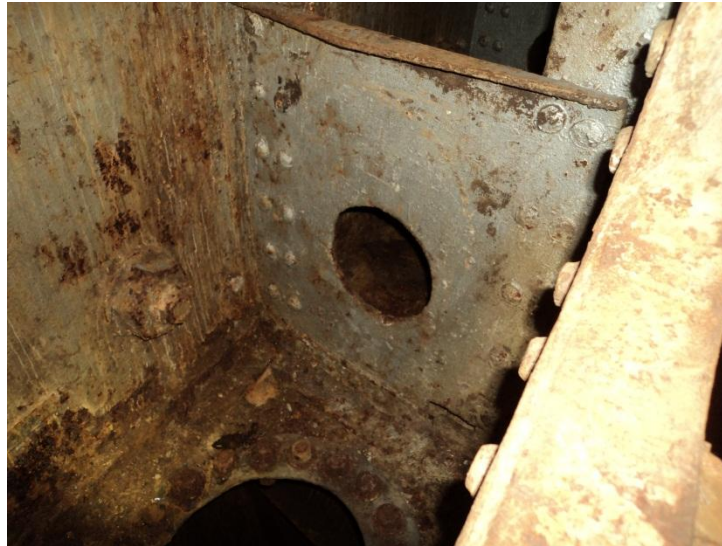
Figure 32. Upper flat of D-92F.

Space is moderately corroded, but not structurally deficient. Upper tank side shell and scantling degraded 20%, floors 30%. Lower flat shows side shell and scantlings degraded 30 – 50% with oil seepage from behind

riveted plate lap seams. Bottom scantlings and shell plating show 30 – 40% degradation in lower flat; no standing water/oil at bottom of tank. Peeling paint and much rust/scale abound.

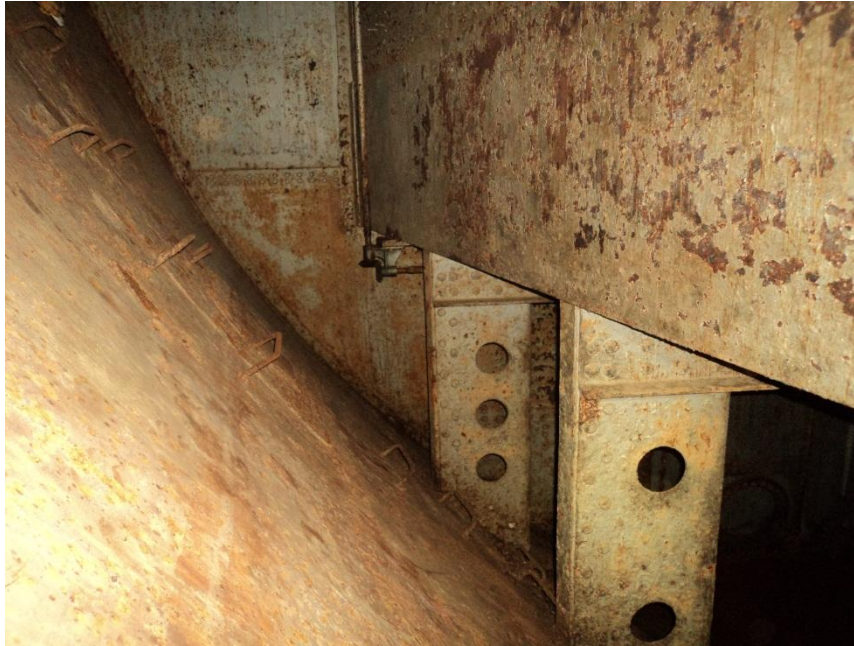
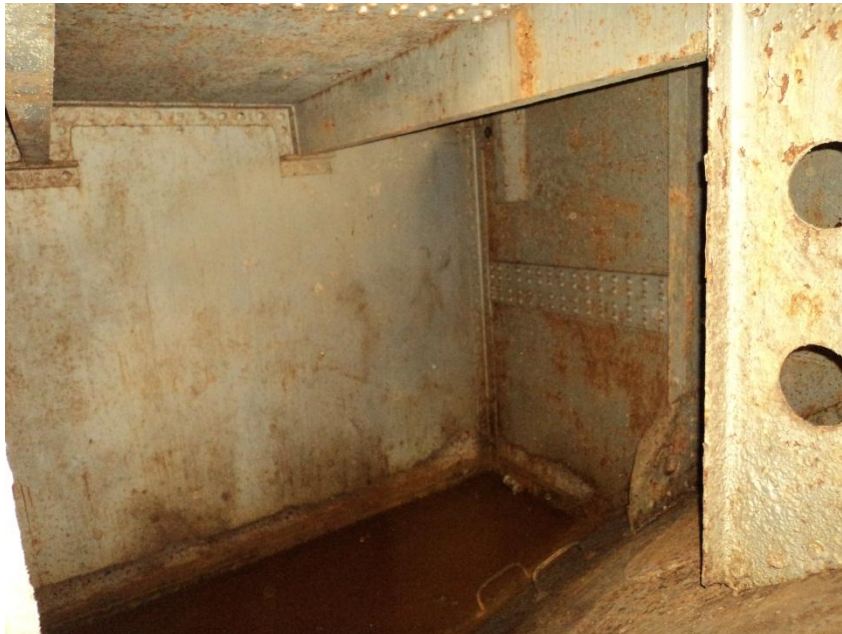
Space is mildly corroded at top with intact coatings; lower compartment has wasted framing. Side shell degraded 20%, floors 30 – 40%, flanges totally wasted. Replace bases of two (2) 3/8" vertical flanges on bottom frames. 4 – 6" standing water/oil. Slight seepage of oil from riveted lap seams on inboard shell.

Figure 34. Lower portion of D-40P showing vertical scantlings.

Figure 35. Bottom of tank in D-40P showing standing water/oil.

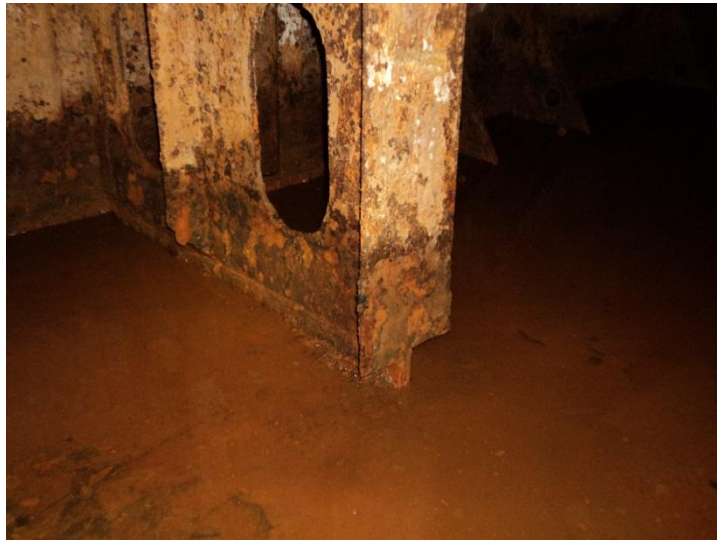
Replace bases of four (4) $\frac{3}{8}$ " x 10" channel stock on the bottom 2' of vertical stanchions. 4 – 6" standing water/oil.

Figure 38. Wasted lower section of vertical stanchion in D-41P.

Ensure adjacent blister tankage is dry. Properly prepare shell plating and install approximately 600 square feet of $\frac{3}{4}$ " A-36 mild steel doubler plating.

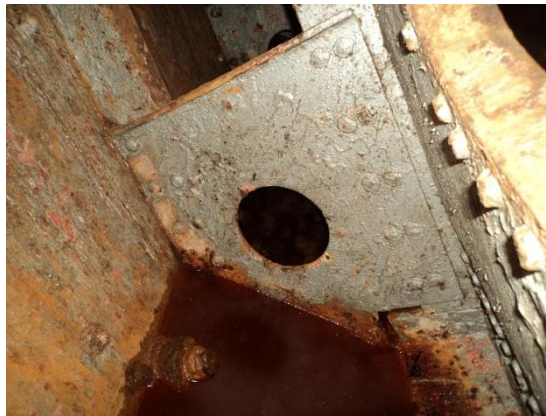
Figure 41. Flooded upper portion of D-90V.

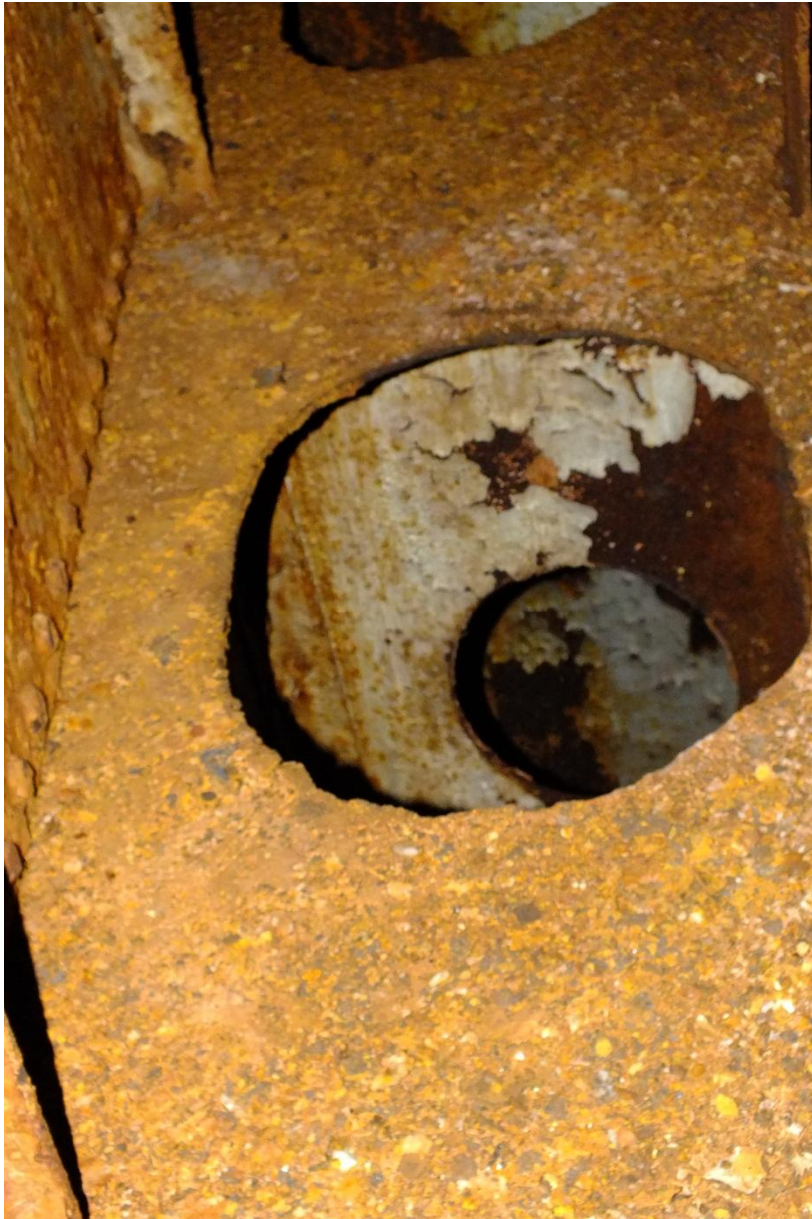
Space is moderately corroded, but not structurally deficient at this point. Upper tank side shell and scantling degraded 30 – 40%, floors 40 – 50%. Lower flat shows side shell and scantlings degraded 50 – 70% with piles of rust (some 10” high). Rivets show wastage of 40%, but no seepage or leaks.. Bottom scantlings and shell plating show 40 – 70% degradation in lower flat; no standing water/oil at bottom of tank. Peeling paint and much rust/scale abound.

Figure 42. Corroded scantlings in A-63S.

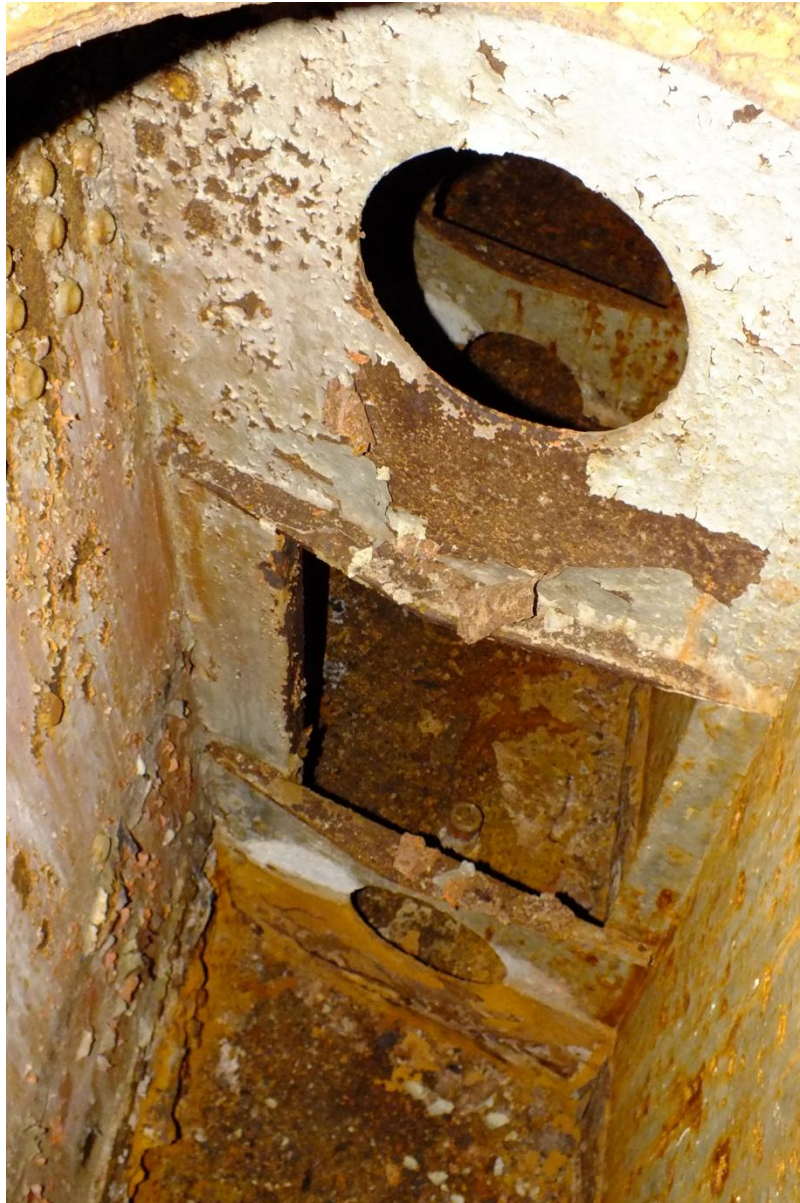
Space is moderately corroded, but not structurally deficient at this point. Upper tank side shell and scantling degraded 30 – 40%, floors 30 – 40%. Lower flat shows side shell and scantlings degraded 40 – 70% with piles of rust (some 10" high). Rivets show wastage of 20 – 30%, but no seepage or leaks. Bottom scantlings and shell plating show 40 – 50% degradation in lower flat; no standing water/oil at bottom of tank. Peeling paint and much rust/scale abound.

Figure 43. Corroded scantlings in A-64S.

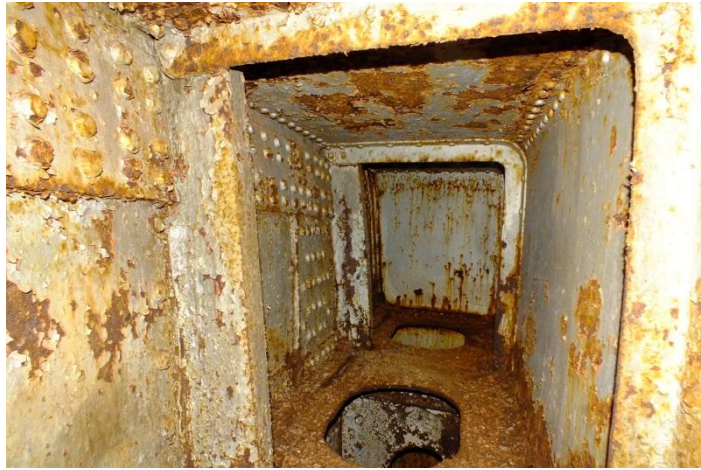
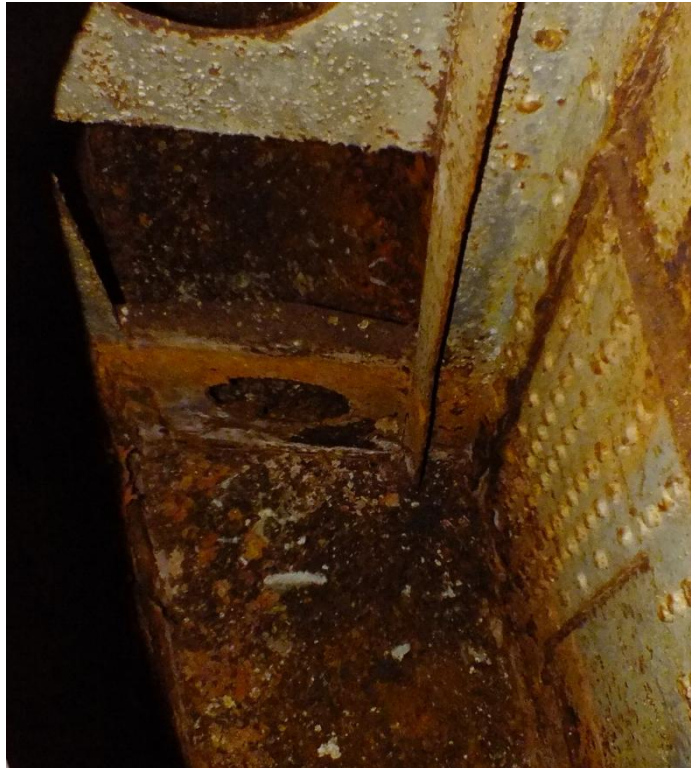
Space is moderately corroded, but not structurally deficient at this point. Upper tank side shell and scantling degraded 20 – 30%, floors 20 – 0%. Lower flat shows side shell and scantlings degraded 25 – 30%. Rivets show wastage of less than 20%, no seepage or leaks. Bottom scantlings and shell plating show 40 – 50% degradation in lower flat; no standing water/oil at bottom of tank. Peeling paint and much rust/scale abound.

Figure 44. Upper flat of A-65S.

Figure 45. Intermediate flat of A-65S.

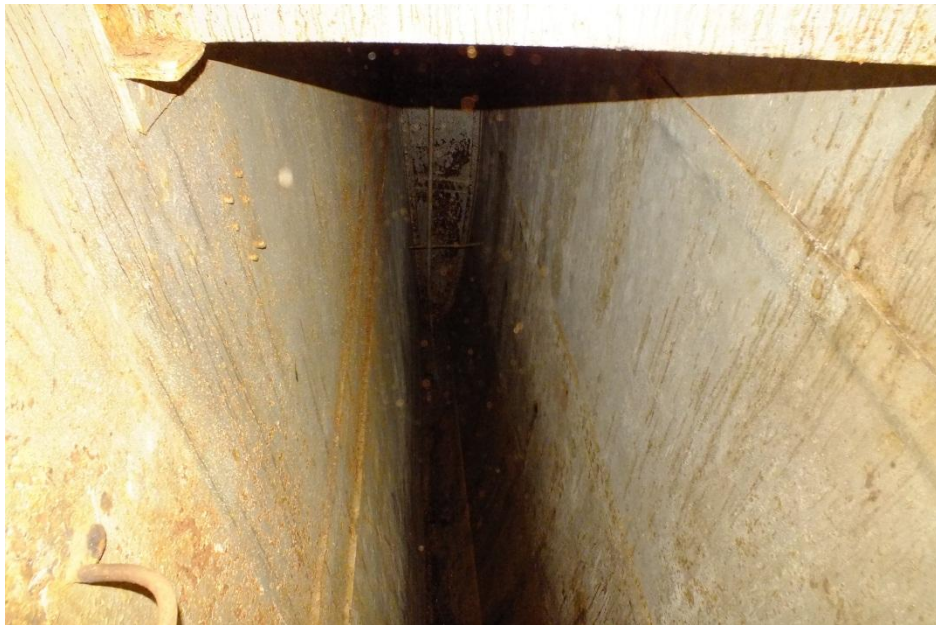
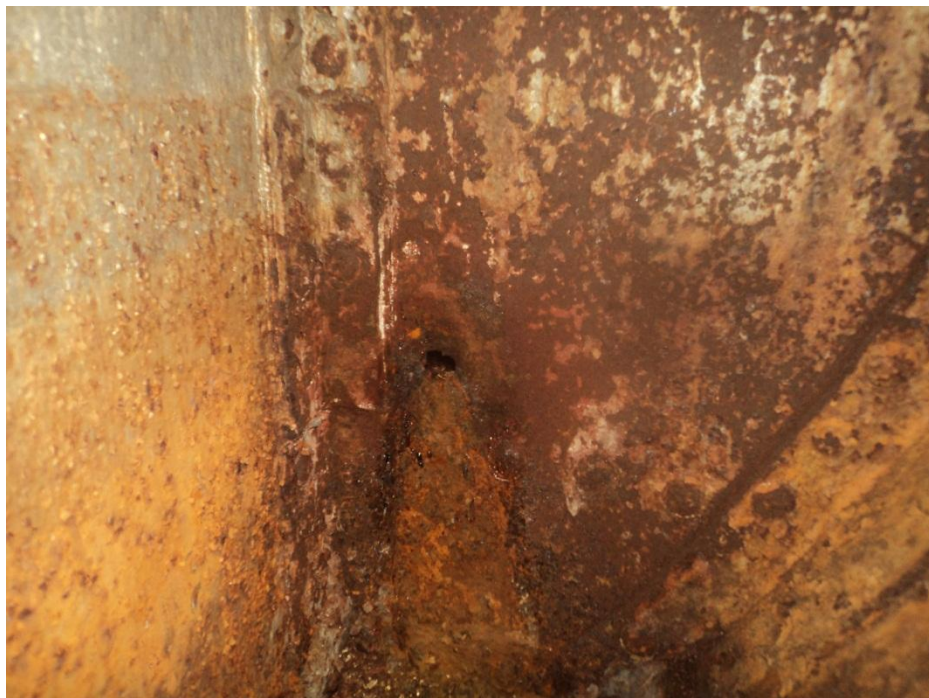
Figure 46. Forward end of A-69S.

Figure 47. Holed plating on forward bulkhead of A-69S.

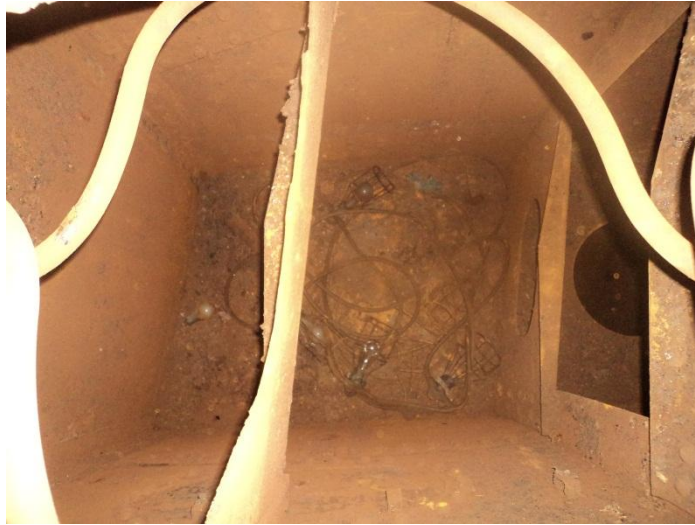
Figure 48. Intermediate flat of A-89F.

Space is moderately corroded, but not structurally deficient. Upper tank side shell and scantling degraded 25%, floors 20 -30%. Lower tank side shell and scantlings degraded 30 – 40%, floors degraded 40%. Rivets degraded 20 – 25%. Peeling paint and much rust/scale abound. No standing water. This space requires no structural repairs or modifications.

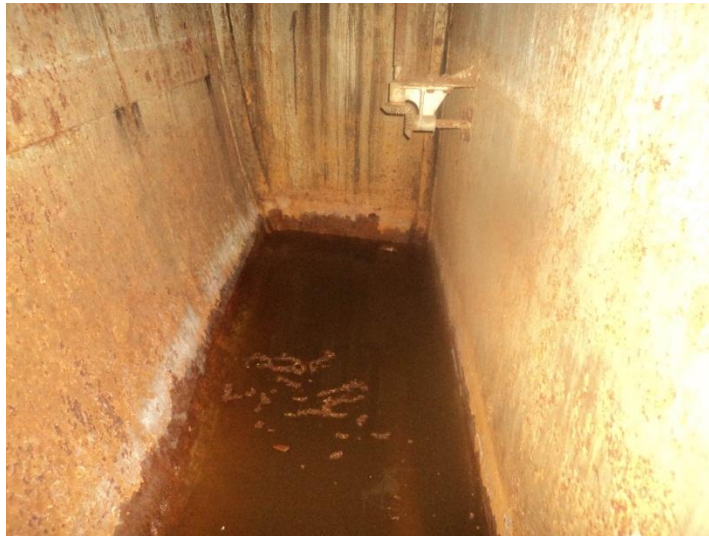
Space is moderately corroded, and mildly structurally deficient. Upper tank side shell and scantling degraded 20%. Lower tank side shell and scantlings degraded 25 – 30%, floors degraded > 40 – 60%. Rivets degraded 20 – 30%. Peeling paint and much rust/scale abound. **3- 4' standing water with 6" of muck beneath.**

Figure 49. Standing water in A-70S.
